# Manhole Inspection Summary

Manhole # S37E\_\_027MH

Insp Date: **11/18/08 12:51 PM**

**Location** Address: **407 saratoga st**

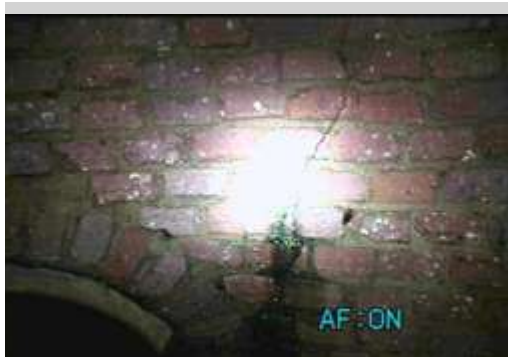
Defect 5

Condition: ☐ Sound ☒ **Cracked** ☐ Root Intrusion ☐ Loose Brick ☐ Deteriorated

Infiltration: ☐ None ☐ Joint ☒ **Cracks** ☐ Mortar ☐ Roots ☒ **Wall**

cracked barrel and infiltration, several places

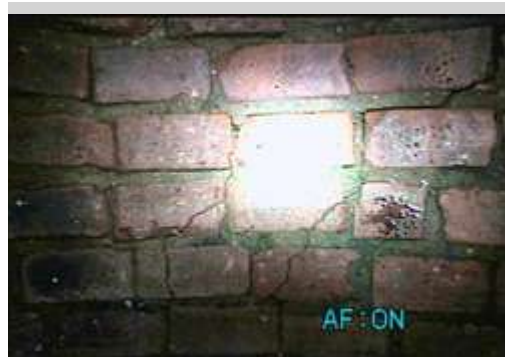
Defect 4

Condition: ☐ Sound ☒ **Cracked** ☐ Root Intrusion ☐ Loose Brick ☐ Deteriorated

cracked corbel

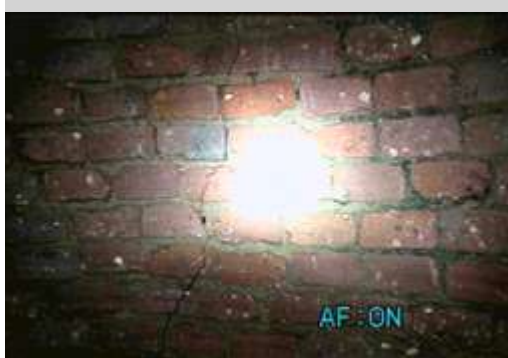
Defect 3

cracked barrel

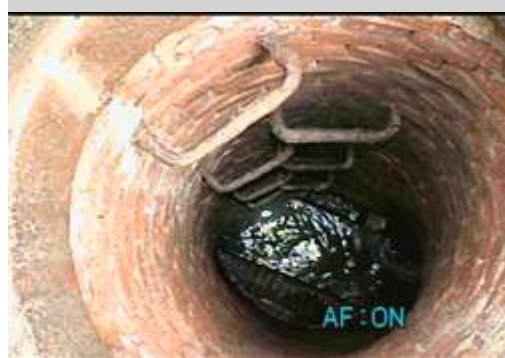
Defect 2

Count: **8** Missing: **0** ☒ **Corroded**

corr steps

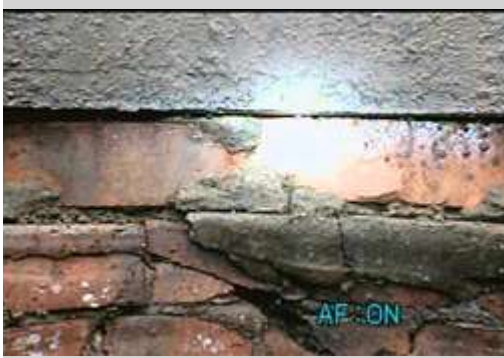
### Defect 1

Condition: ☐ Sound ☒ **Cracked** ☐ Root Intrusion ☒ **Loose Brick** ☒ **Deteriorated**

Infiltration: ☐ None ☒ **Joint** ☐ Cracks ☐ Mortar ☐ Roots ☐ Wall

cracked chimney and infiltration, frame  
adj
